# Television

Chassis

ITC008

## TECHNICAL INFORMATION N°2003 - 38

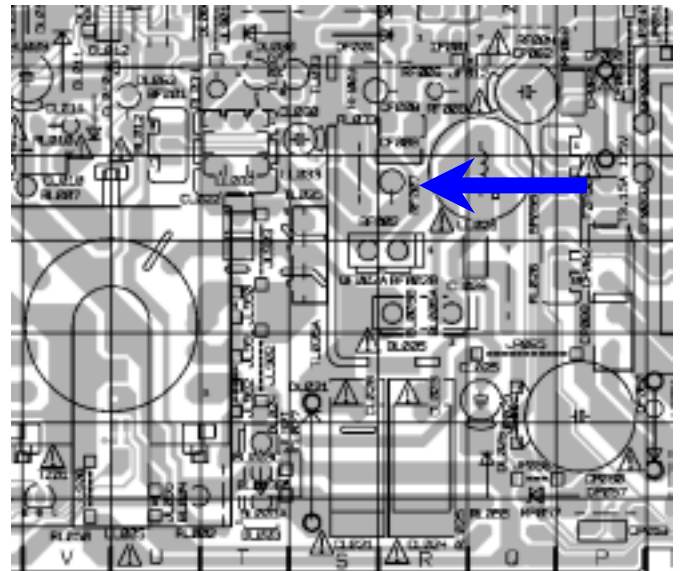
Horizontal line rolling down the screen from the top to bottom.

- Change resistor at location RF007 from a 1.21Ω to 1Ω 1% 0.700W (**PART No 10254220**).
- Remove the resistor at location RL130 (EWM Board).

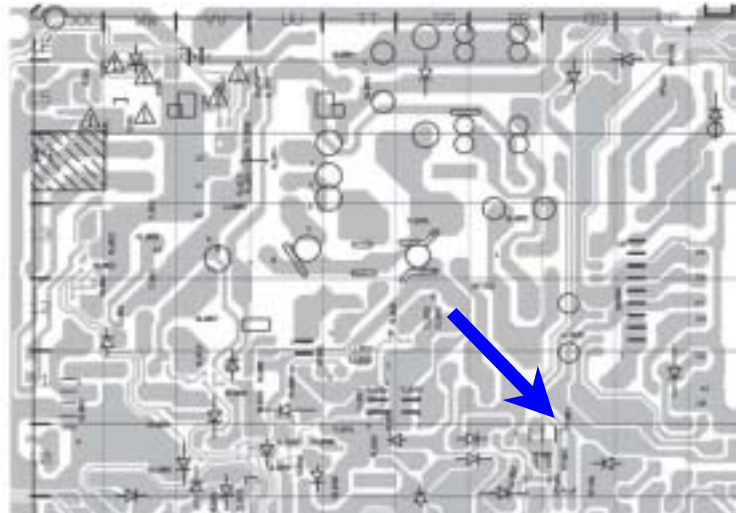
**Symptom / Problem observed :**  
A vertical jitter appears after a certain time or immediately after the switch on.

**Cause :**  
The capacitor CF004 is defective.

**Solution :**  
- Replace CF004 capacitor by another of the same value (1nF 50V) **PART No 10138550**.

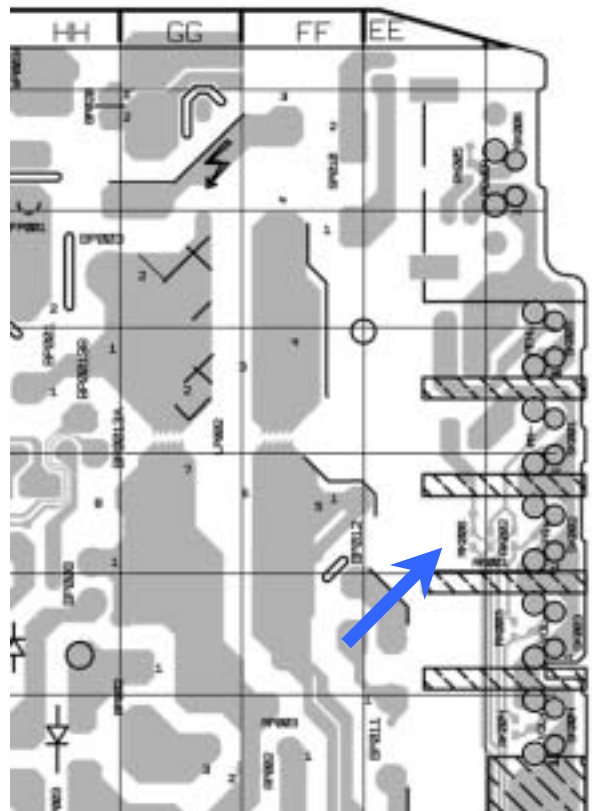
After 2 or 3 working hours, the set switch OFF and switch ON again without apparent reason.  
(The symptom is repeated every 45 minutes)

Remove the resistor in position RK006.
