PROCEDURE OF MOUNTING ADDITIONAL FILTER CAPACITOR for ETHERNET BOARD **VERSION 1.1**

To avoid the problem of stop communication via ETHERNET (X403, XC403)

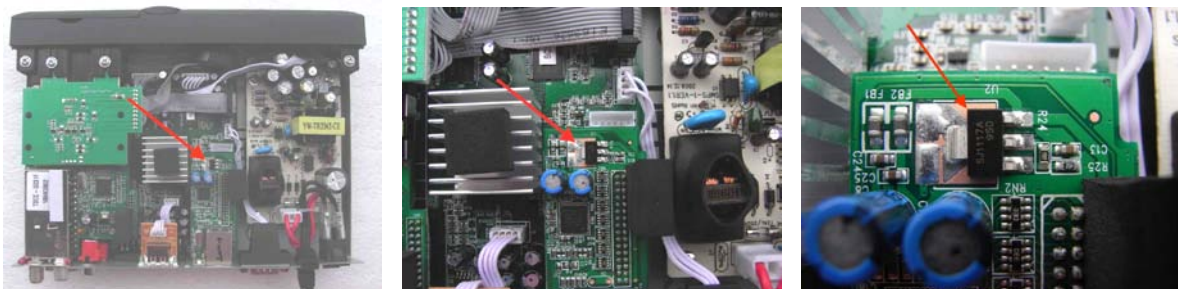
Located on the centre of motherboard there's Ethernet adaptor card with U2 component - LDO voltage regulator:

Problem disappears when additional filtering electrolyte capacitor (we used **100 μ F/16V 105°** - **capacity is critical and should not be replaced by smaller one!**) is connected between output of voltage regulator and ground. Because there's no sure ground point around U2, remove varnish from cooper at PCB corner. (See below picture).

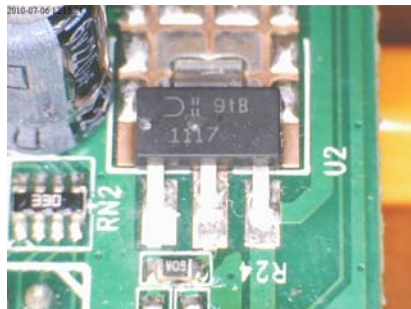
Picture 1 – good component

Until now we got 4 releases of Ethernet board versions. IC from picture 1 were mounted on PCB from picture 3 (0952). IC from picture 2 was mounted on PCB from picture 4,5,6 (1010, 1014 and 1017). **WE REPORTED THIS PROBLEM ONLY WITH CHIP FROM PHOTO 2 (MOUNTED ON BOARDS 1010, 1014 1017).**

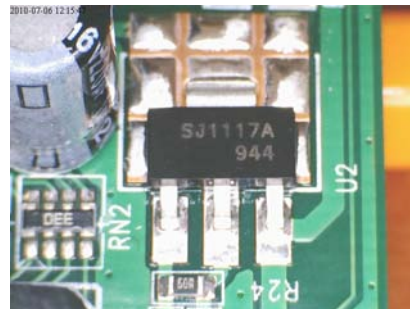
Picture 2 – bad component

Problem appears when U1 – Ethernet chip get to high temperature. For testing environment I used HOT AIR to increase U1 temperature (temperature set to 200°C) and oscilloscope to analyze output from U2 (middle pin or radiator). After while of heating, oscilloscope shows high frequency sinus oscillations (set to AC coupling, Y:10mV/div and X:2μS/div). This causes stop communication via Ethernet.
